Project Category: Residential Interior Element

Residential Interior: \$30,000 and Under

Completion Date: November 25, 2019

Location: Madison, WI

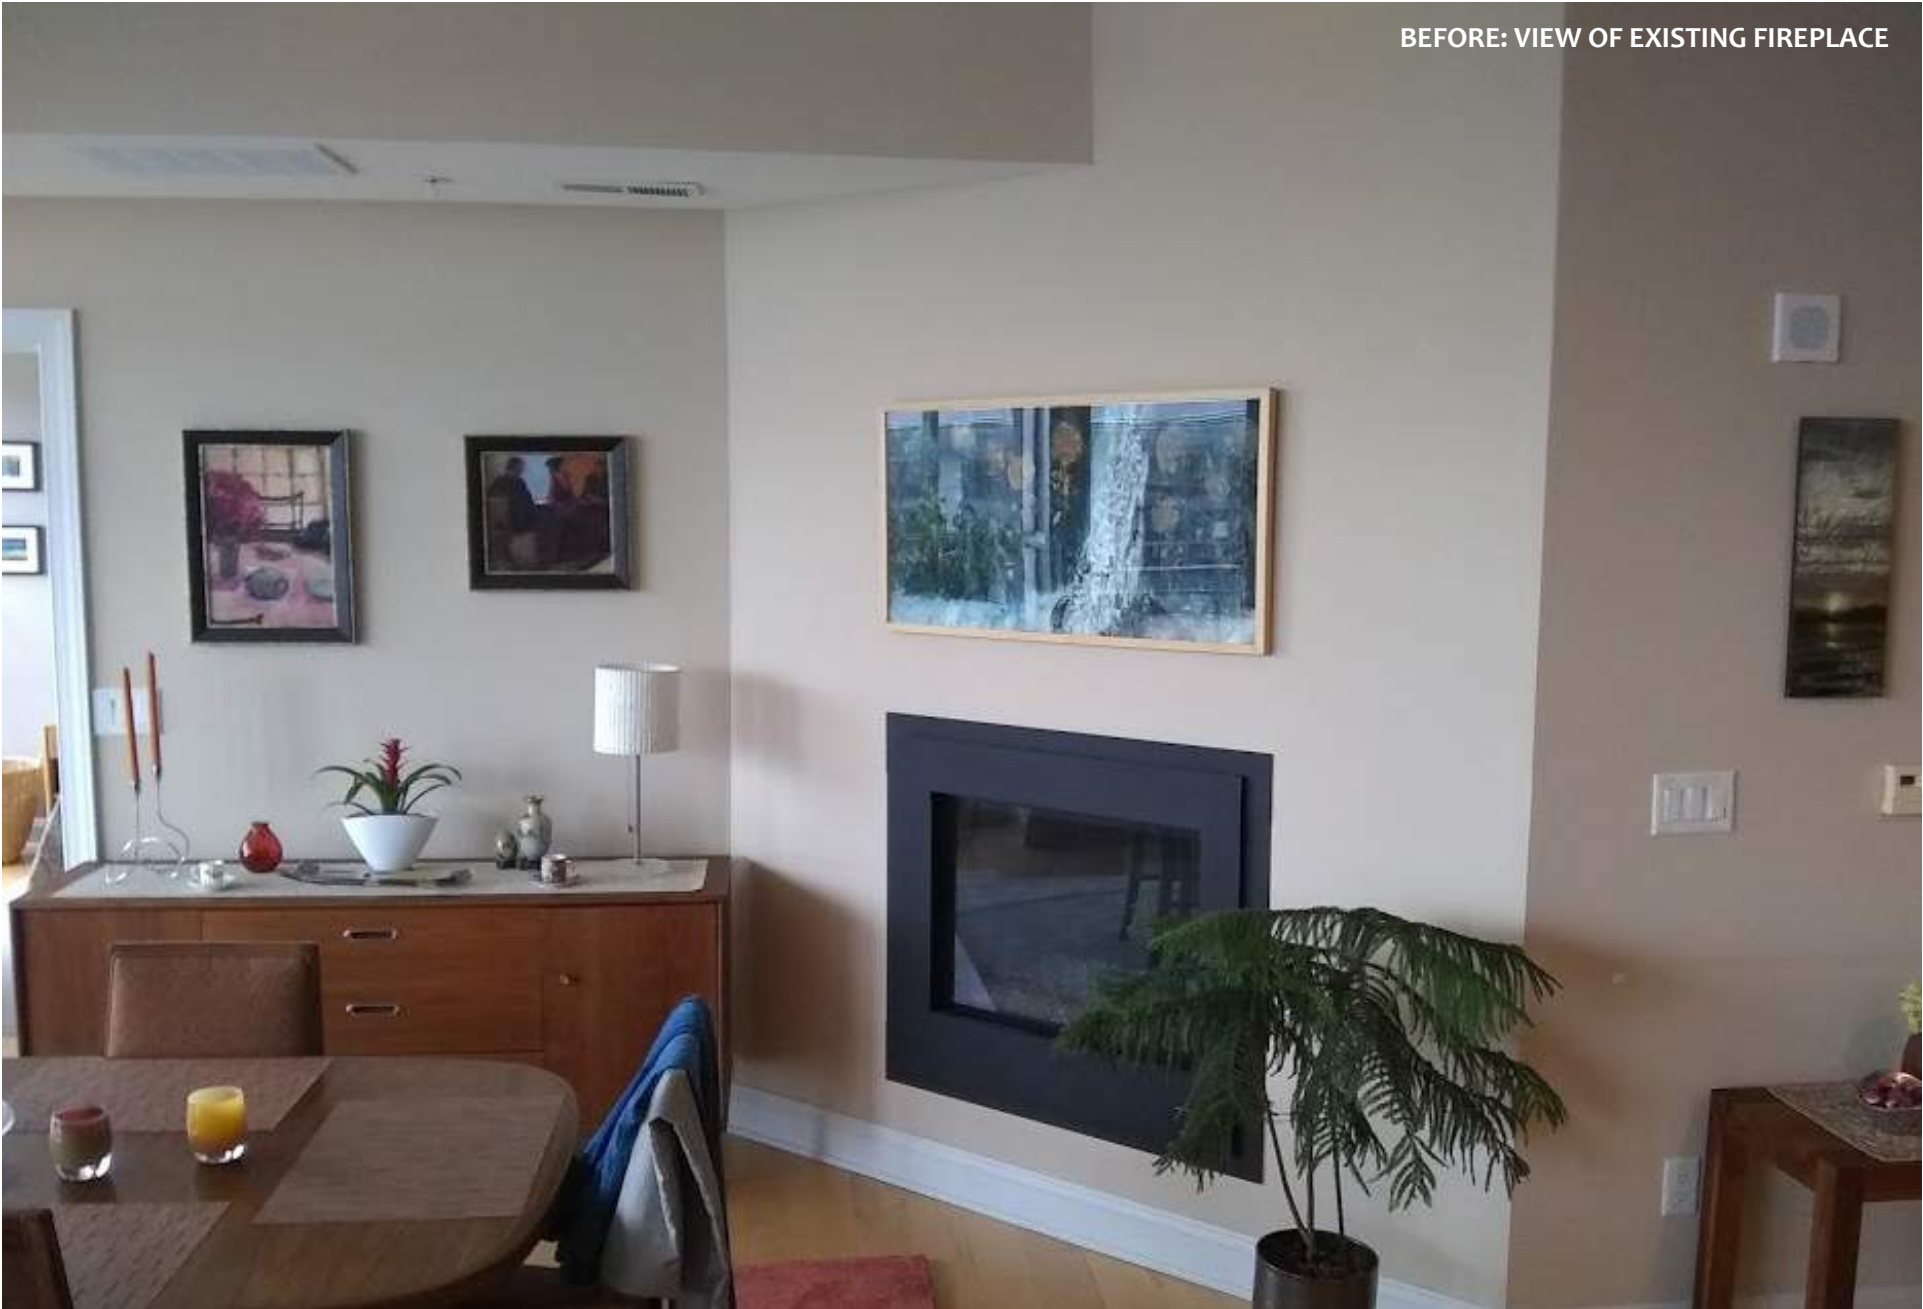
BEFORE: VIEW OF EXISTING FIREPLACE

First was the fireplace, which was in an unusual position near the dining table. It was not well utilized or well seen within the unit.

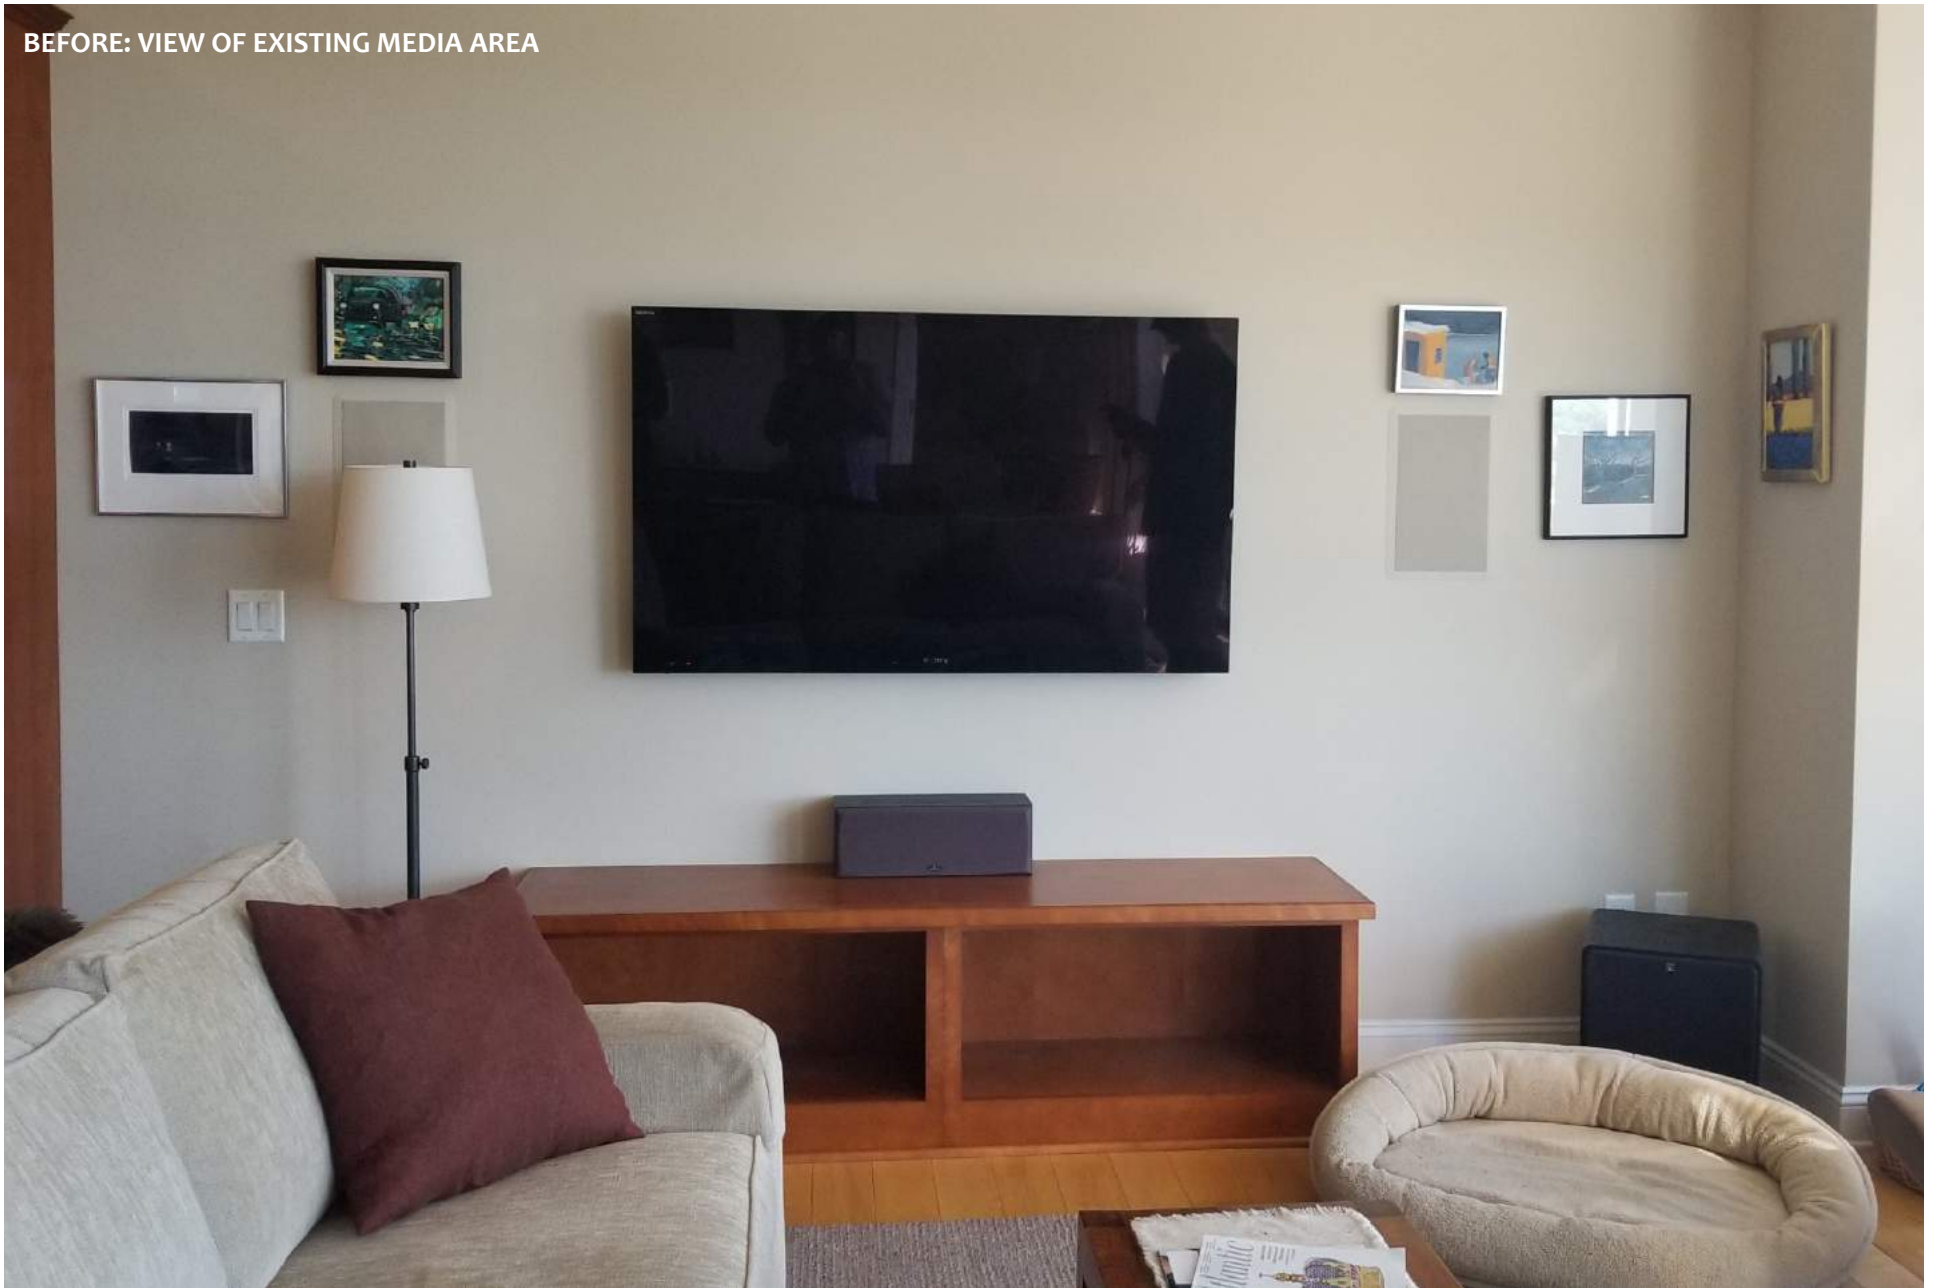
BEFORE: VIEW OF EXISTING MEDIA AREA

Second was the media area. While centered within the available wall space, it did not work out with the furniture layout. It was off-center from the ideal viewing position, and to move it so that it could be positioned with the furniture would leave it off-center in the space.

- The TV needed to move closer to the window wall in order to provide a better viewing angle that fits with the position of the prime viewing area of the sectional.
- Shelving and cabinetry was required to accommodate the electronics.
- A gas fireplace located on the other side of the room, in the wrong location, was eliminated so that an electric fireplace can be installed as part of the feature wall.
- The design of the wall was to be visually compelling, creating a modern look using products such as tile and wood that have visual and textural interest.

A key functional improvement is that the viewing location for the TV is now ideally located relative to their furniture. Before the TV was centered in the available wall space, but, was off center from the furnishings. By inserting the fireplace to the left side of the arrangement, the TV now becomes centered in its ideal viewing location.

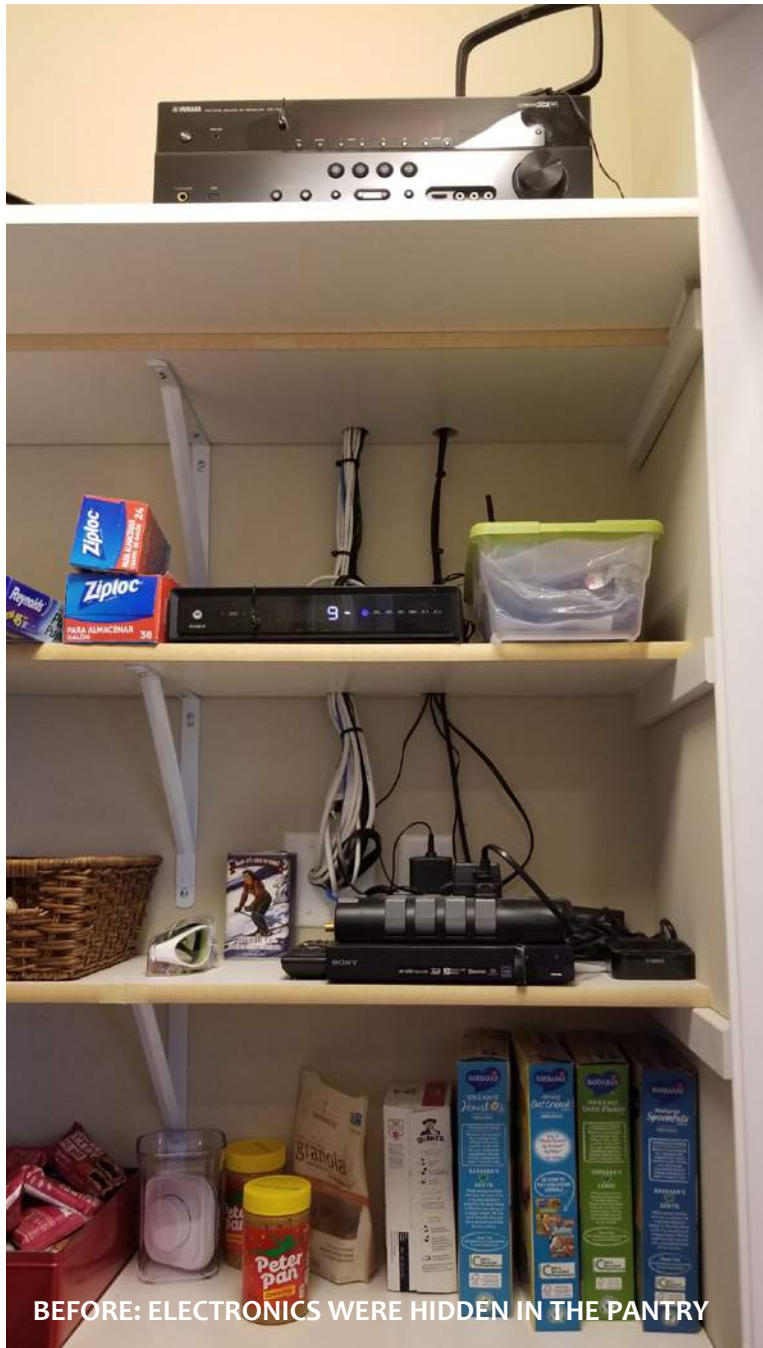
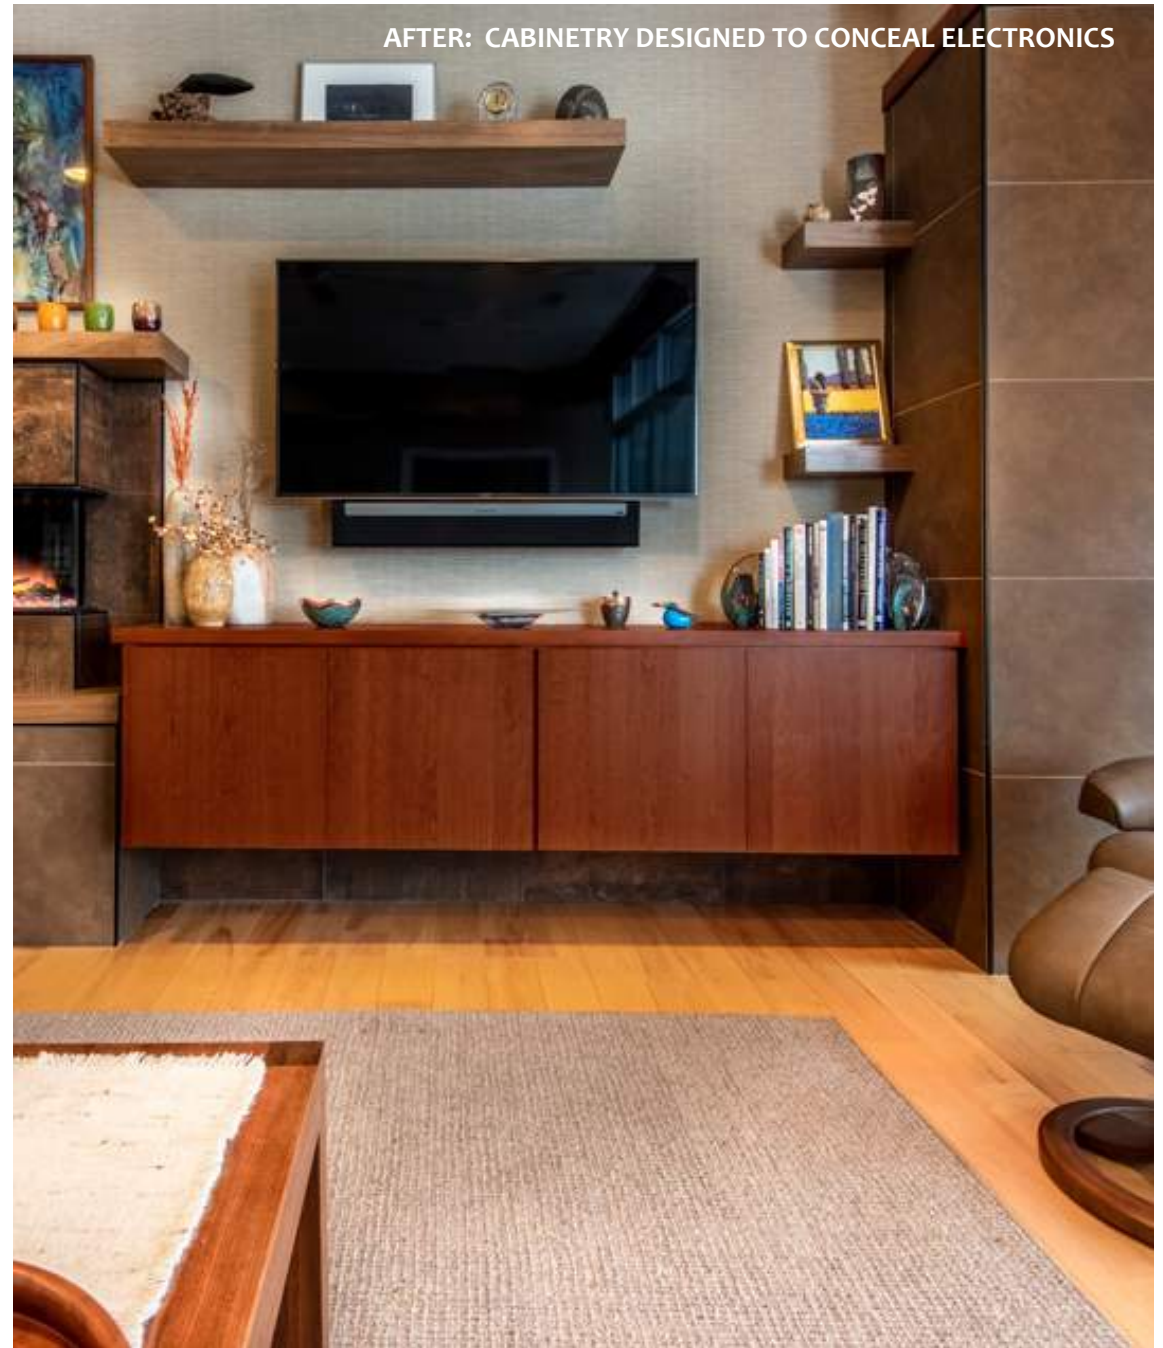
The electronics for the TV were well hidden in the pantry (left), but this was not ideal, as it took away valuable space. The requested cabinetry and shelving (right) was integrated to accommodate the electronics that support the TV and audio.

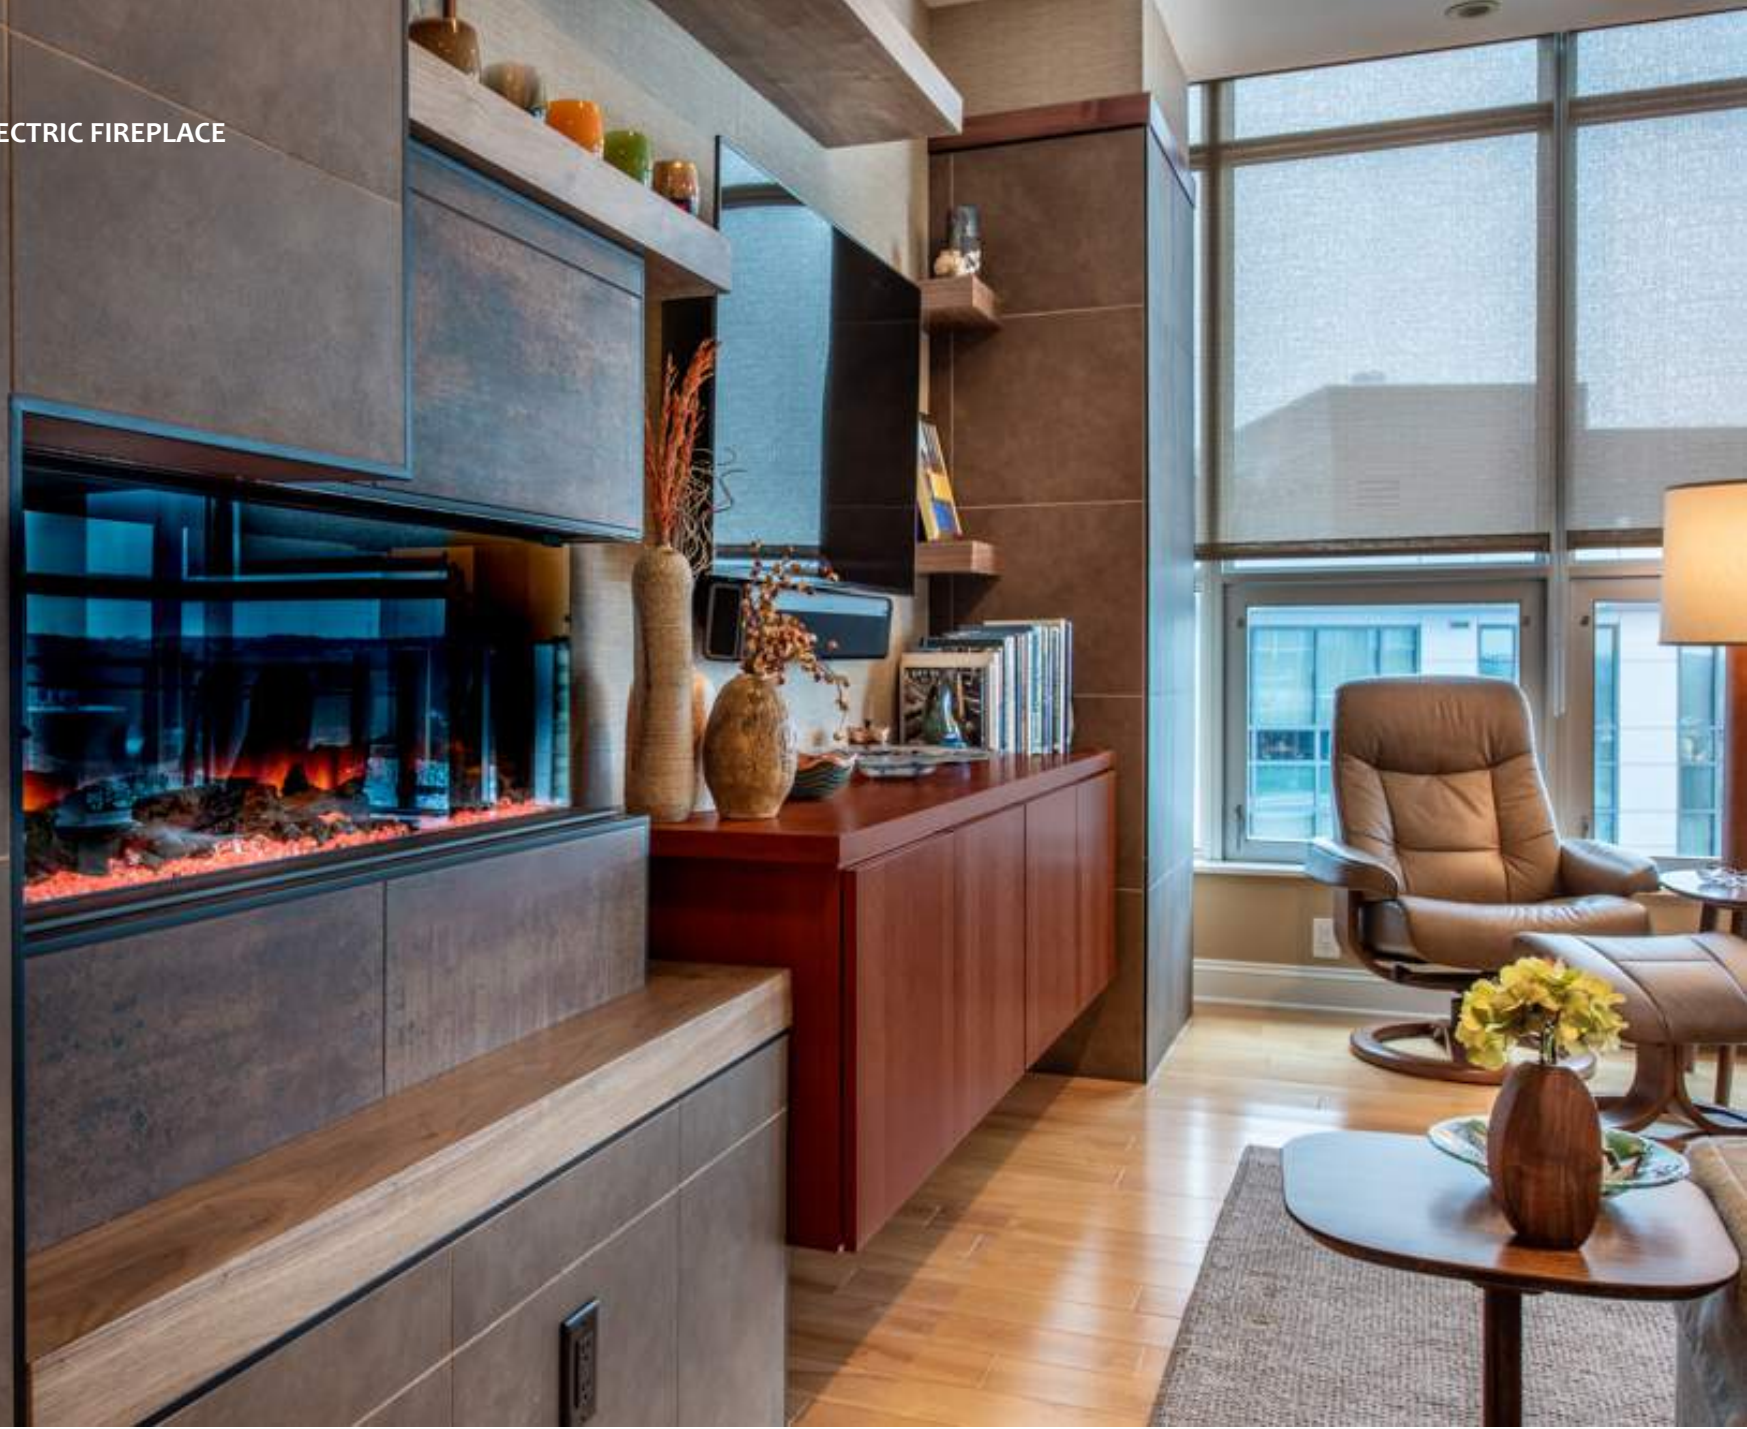
AFTER: VIEW OF ELECTRIC FIREPLACE

Our clients had begun some research on their own and discovered an electric fireplace that they were pleased with. It simplified the process since the gas did not need to be routed, and it also gave design flexibility since the size and constraints were very different from a gas fireplace.

We installed an electric fireplace in the process of building this feature wall. But, typically, a fireplace surround is uniform in plan where it meets the fireplace. It's flat. A mantel and pilasters might add depth, but that depth is separated from the fireplace by several inches. In this case, we went about it differently. The fireplace is part of a sculptural element. The fireplace is inset inside an L shaped column on the left side, and the different tile planes that properly intersect the finished edge of the fireplace. All this required extra study of the fireplace specifications and planning to properly frame, yielding this innovative end result.

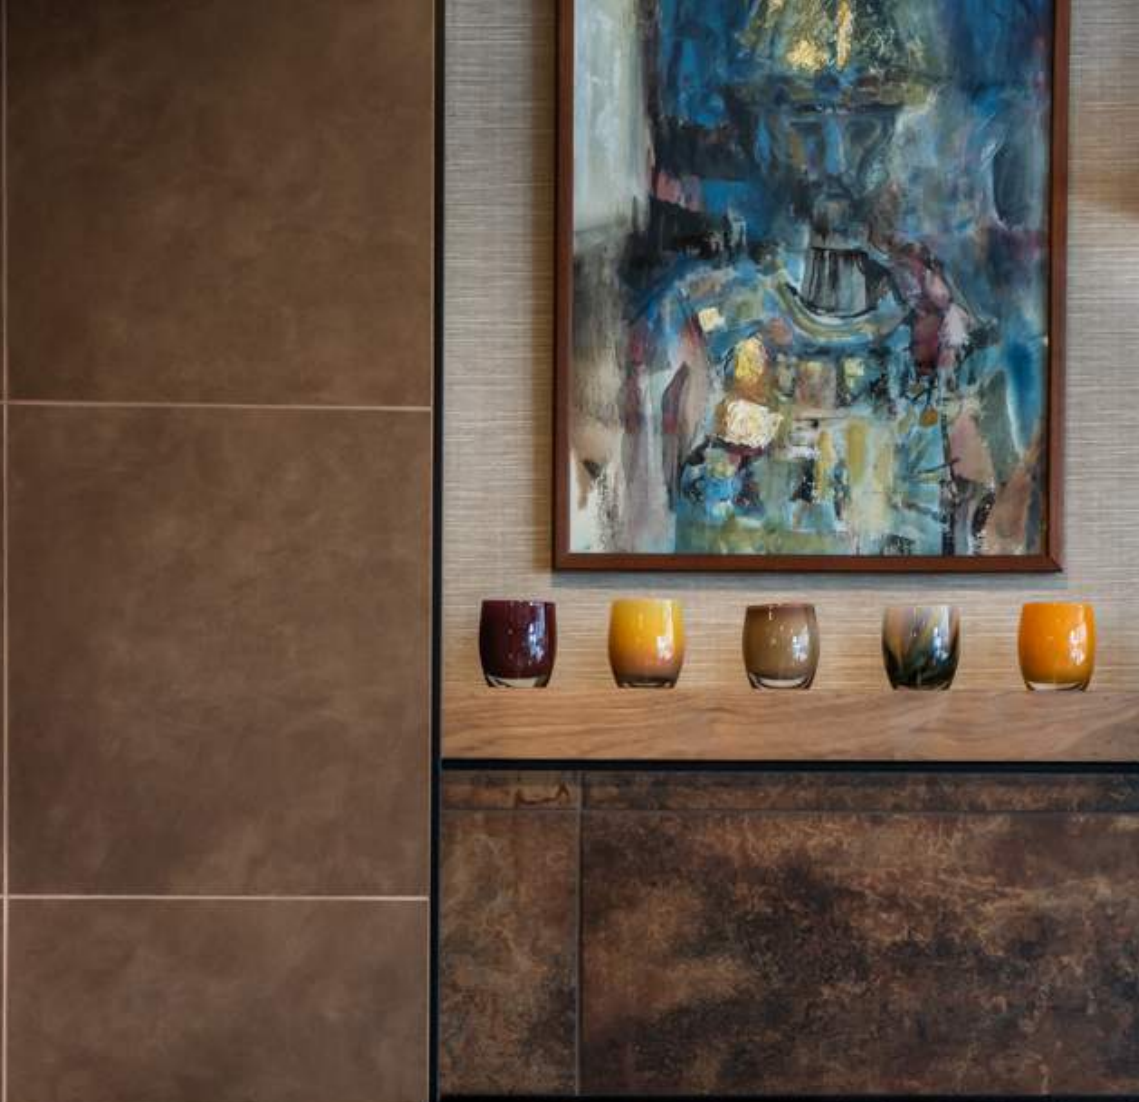
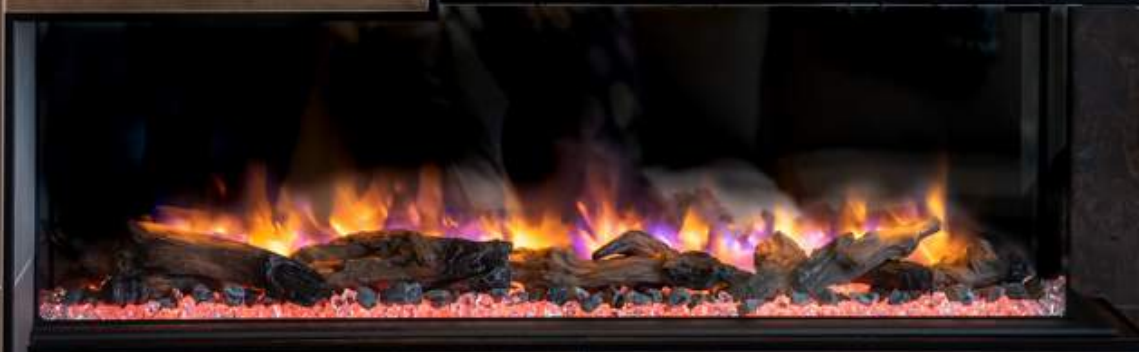
AFTER: THE ELECTRIC FIREPLACE CREATED THE OPPORTUNITY FOR A MORE UNIQUE AND ARTISTIC DESIGN

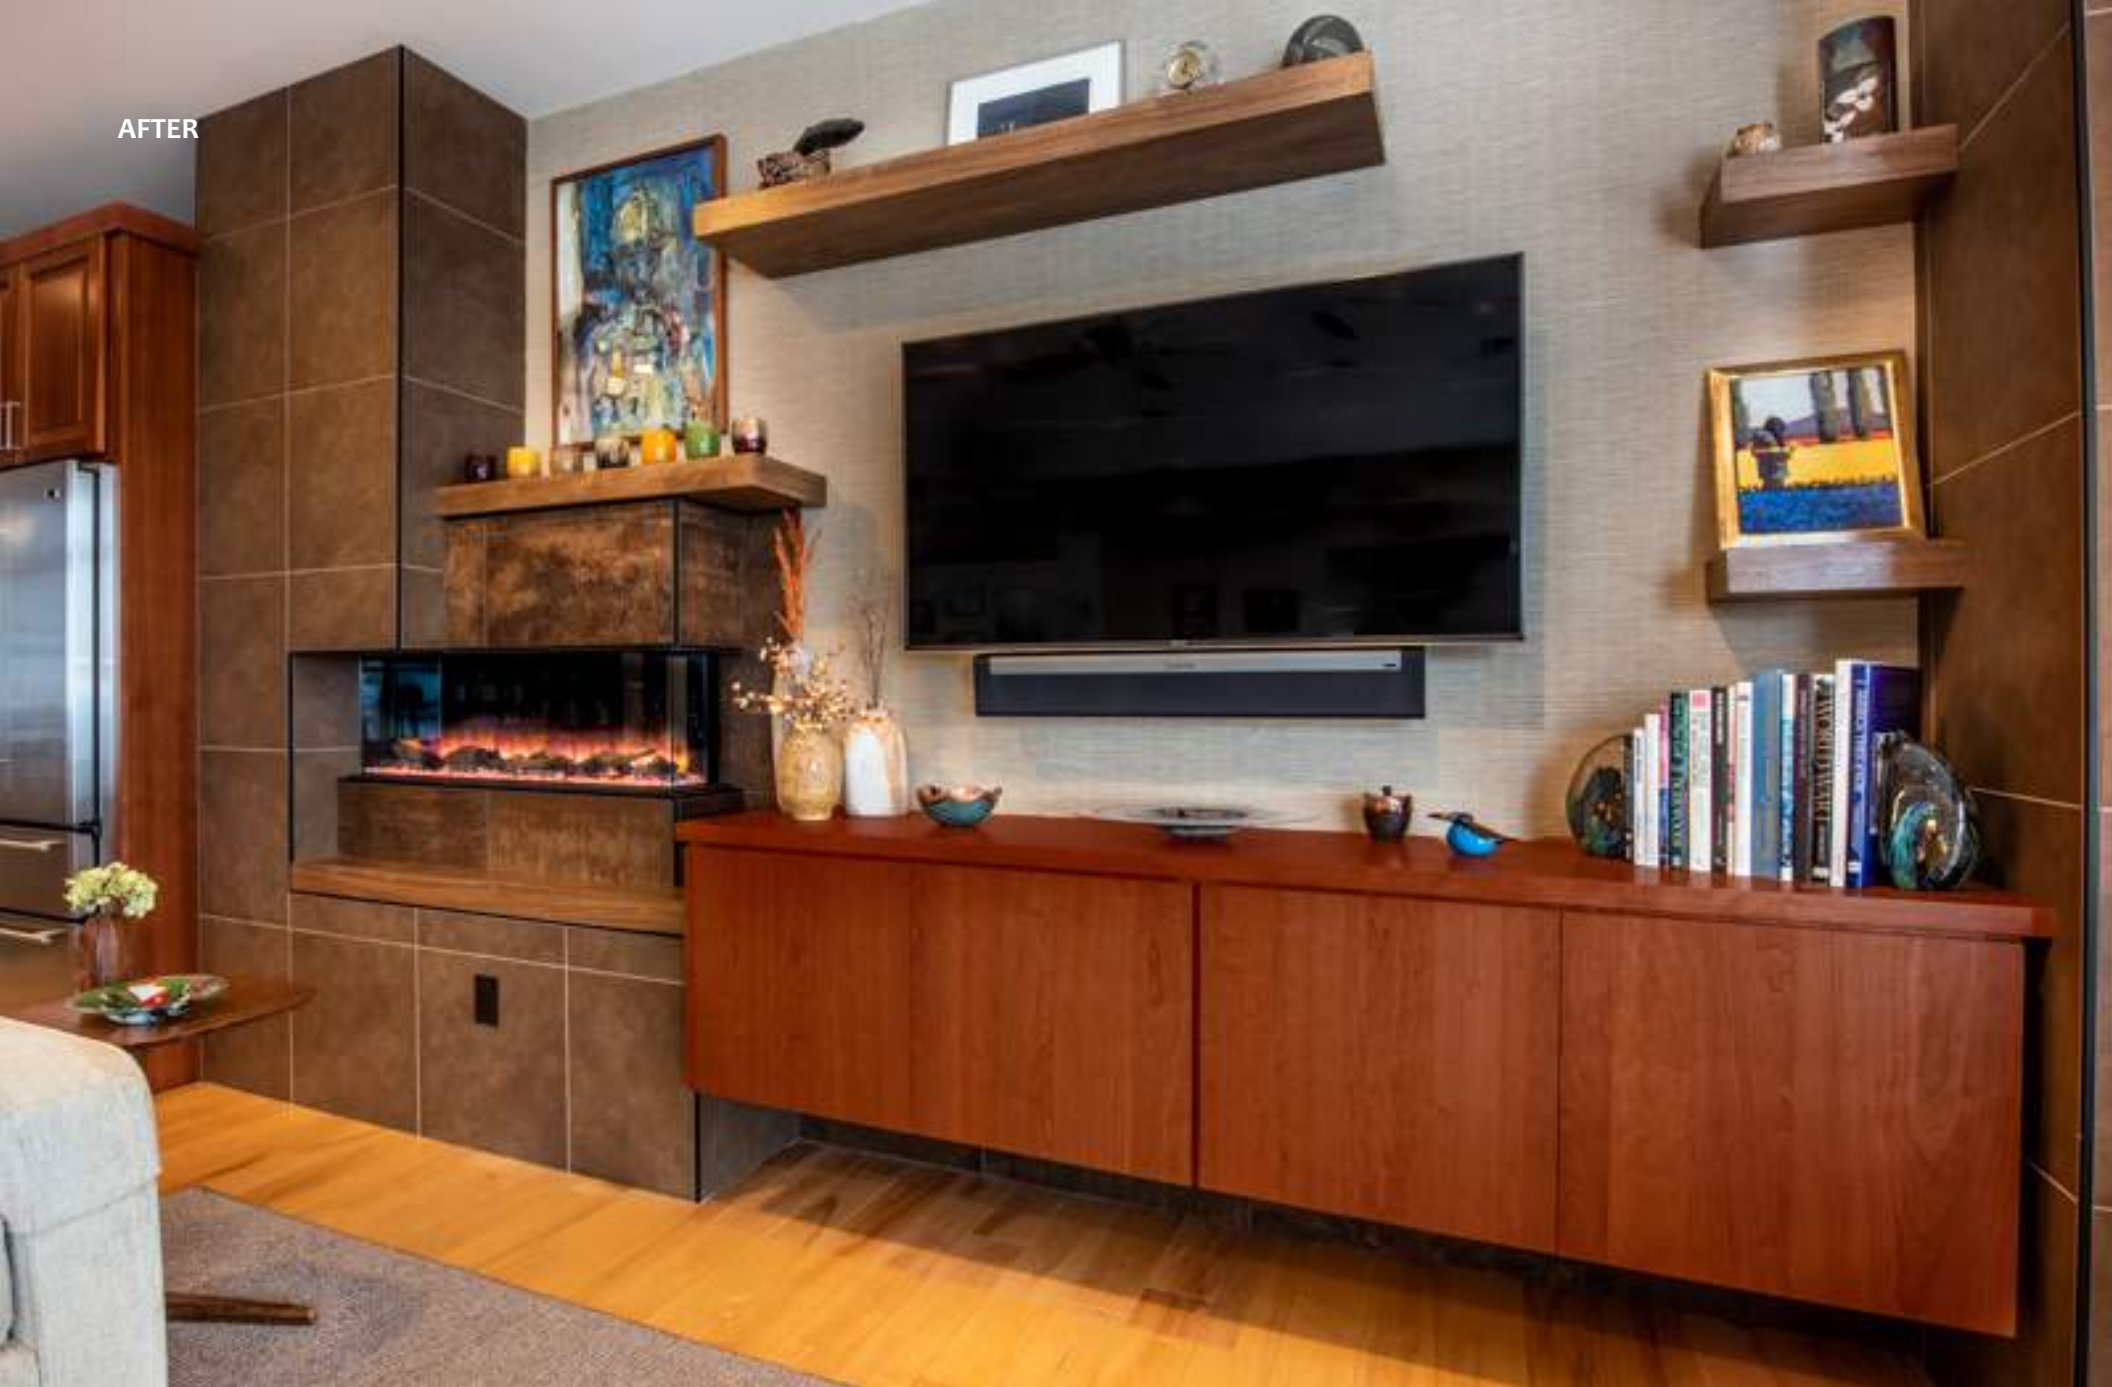
Having remodeled several homes in prior cities, our clients had a good feel for the design aesthetic that they were looking for. Our interpretation was a visually compelling, modern look, using products such as tile, wood, and wallpaper that provide visual and textural interest.

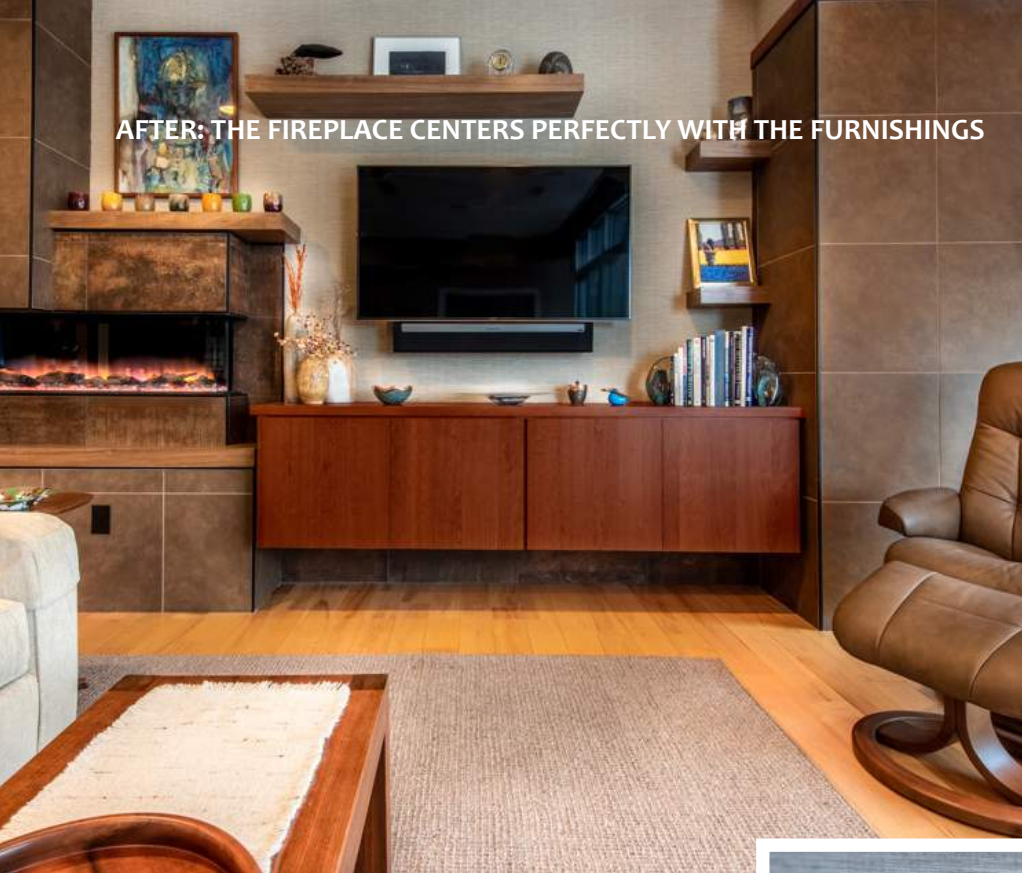
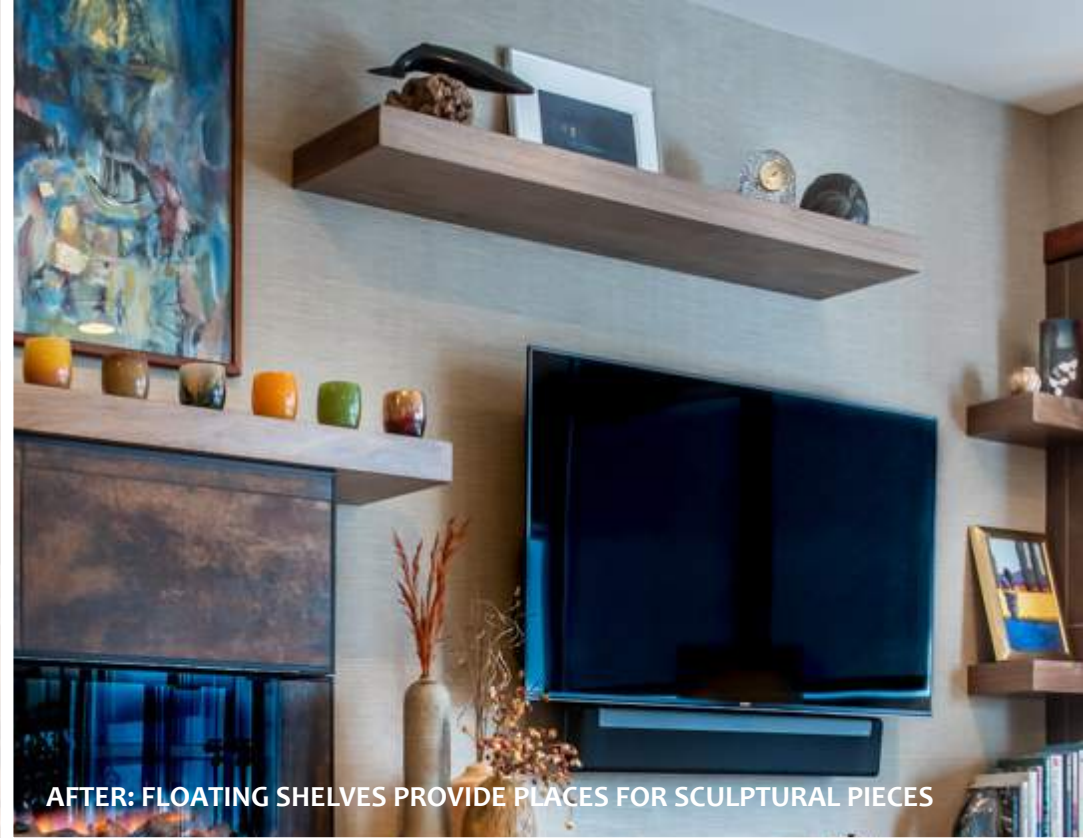
AFTER: THE FIREPLACE CENTERS PERFECTLY WITH THE FURNISHINGS

AFTER: FLOATING SHELVES PROVIDE PLACES FOR SCULPTURAL PIECES

The design choices were narrowed down to a single option, with integrating volumes intersecting around the fireplace, and a balanced sense of asymmetry. Two different tiles contrast each other making the volume stand out. Thick pieces of wood form a non-traditional hearth and mantel, which match with the floating shelves, and wallpaper provides visual interest and texture, tying the whole wall together beautifully.

- Tile built around existing boxed-out structural column on the right integrated with the new box-out and fireplace at the left side.
- The way that the left side ties in the existing kitchen cabinetry.
- Hand-built floating shelves constructed by our team from walnut veneer plywood.
- The tile around the electric fireplace is not all in one place. Extremely careful planning was needed in order to frame this detail and to execute the tile work so that it all ties in precisely, with all reveals matching just as designed.
- Perfect tile work: the grout lines are precise, and the tile faces align perfectly.

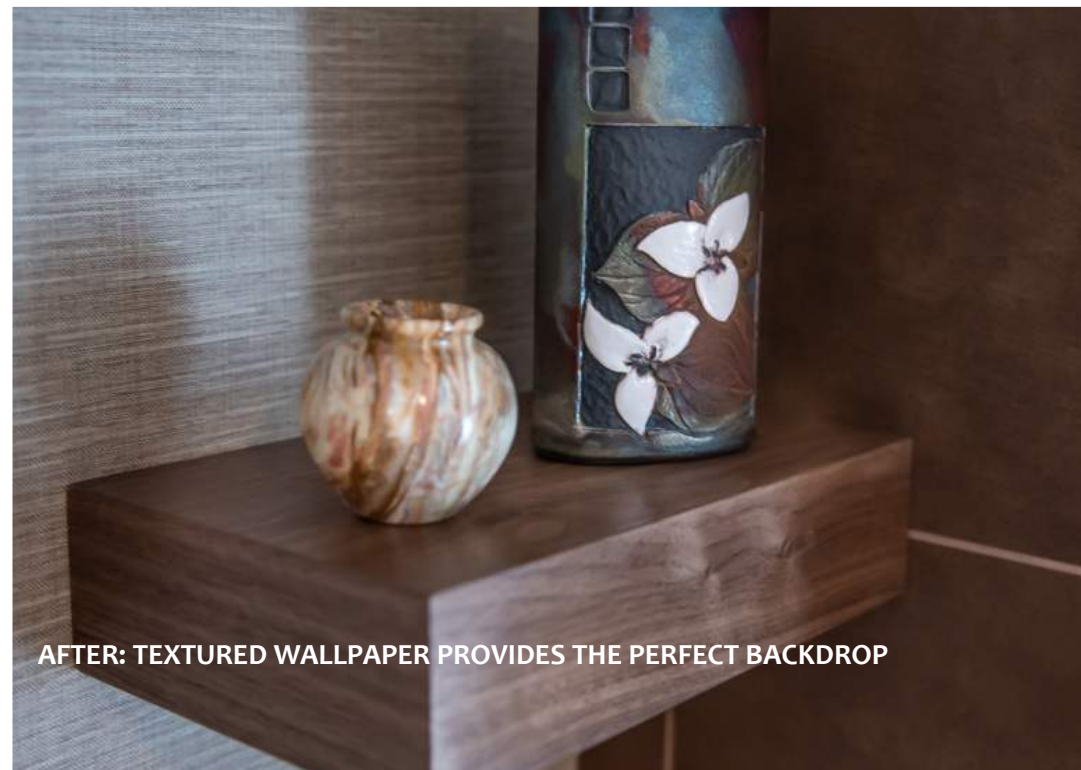
AFTER: TEXTURED WALLPAPER PROVIDES THE PERFECT BACKDROP

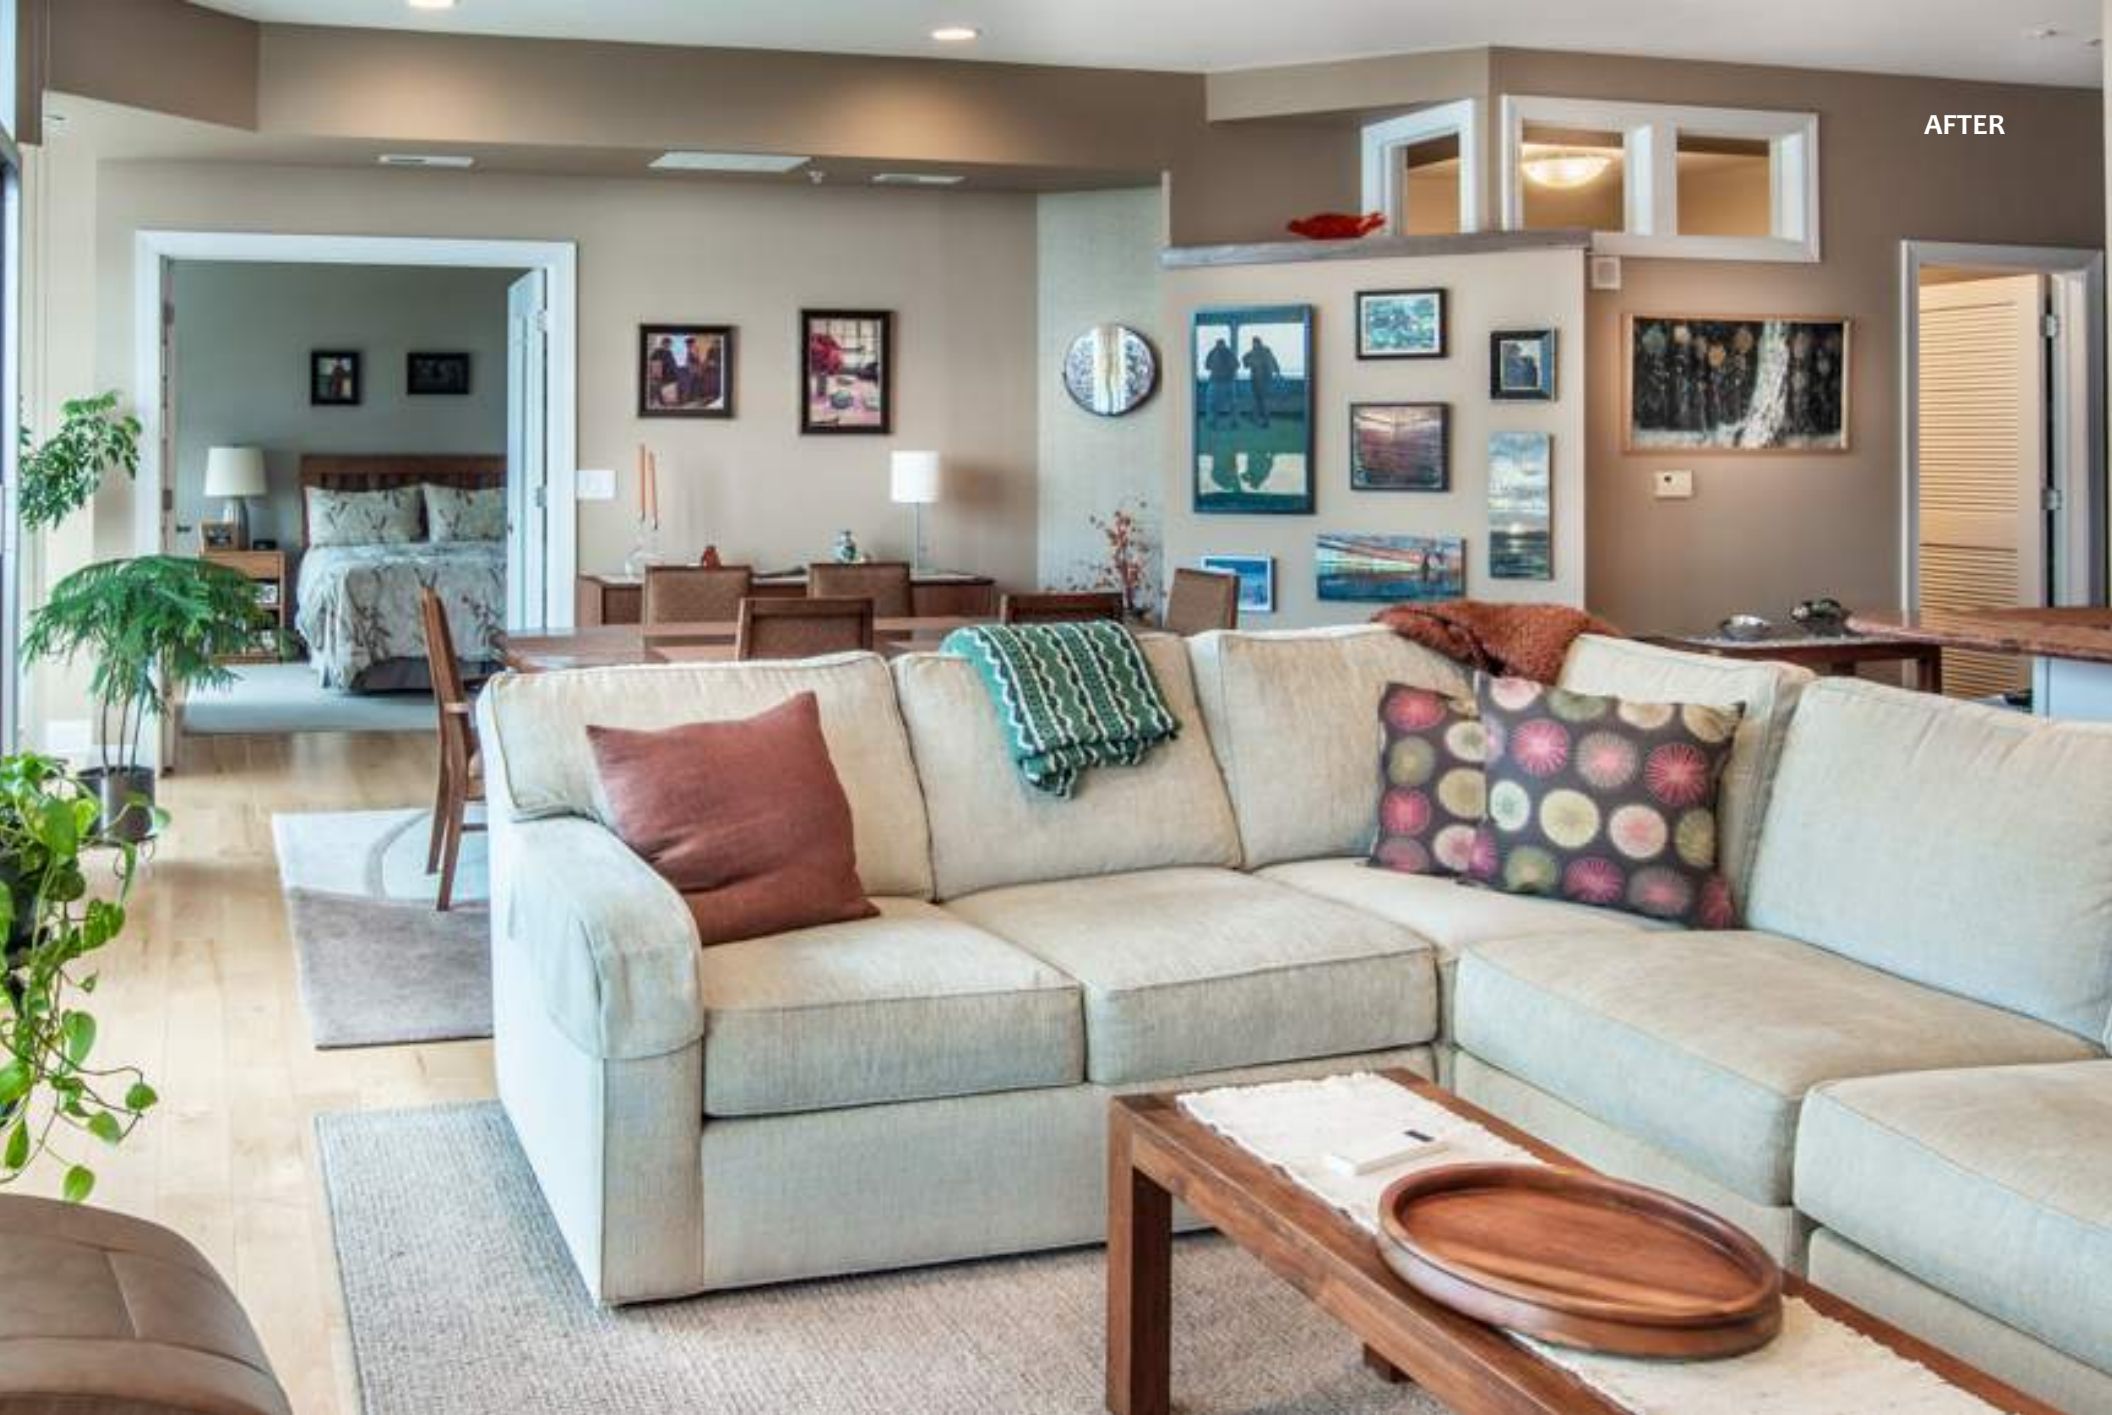
Across the way, where the fireplace used to be, now there is space for an art wall. But like the entertainment area, it is not just an ordinary art wall. It is a plane that extends just beyond the hallway in order to provide visual interest as you walk in the main entrance of the condo.
