Project Category: Residential Interior Element

Residential Interior: \$30,000 and Under

Completion Date: November 25, 2019

Location: Madison, WI

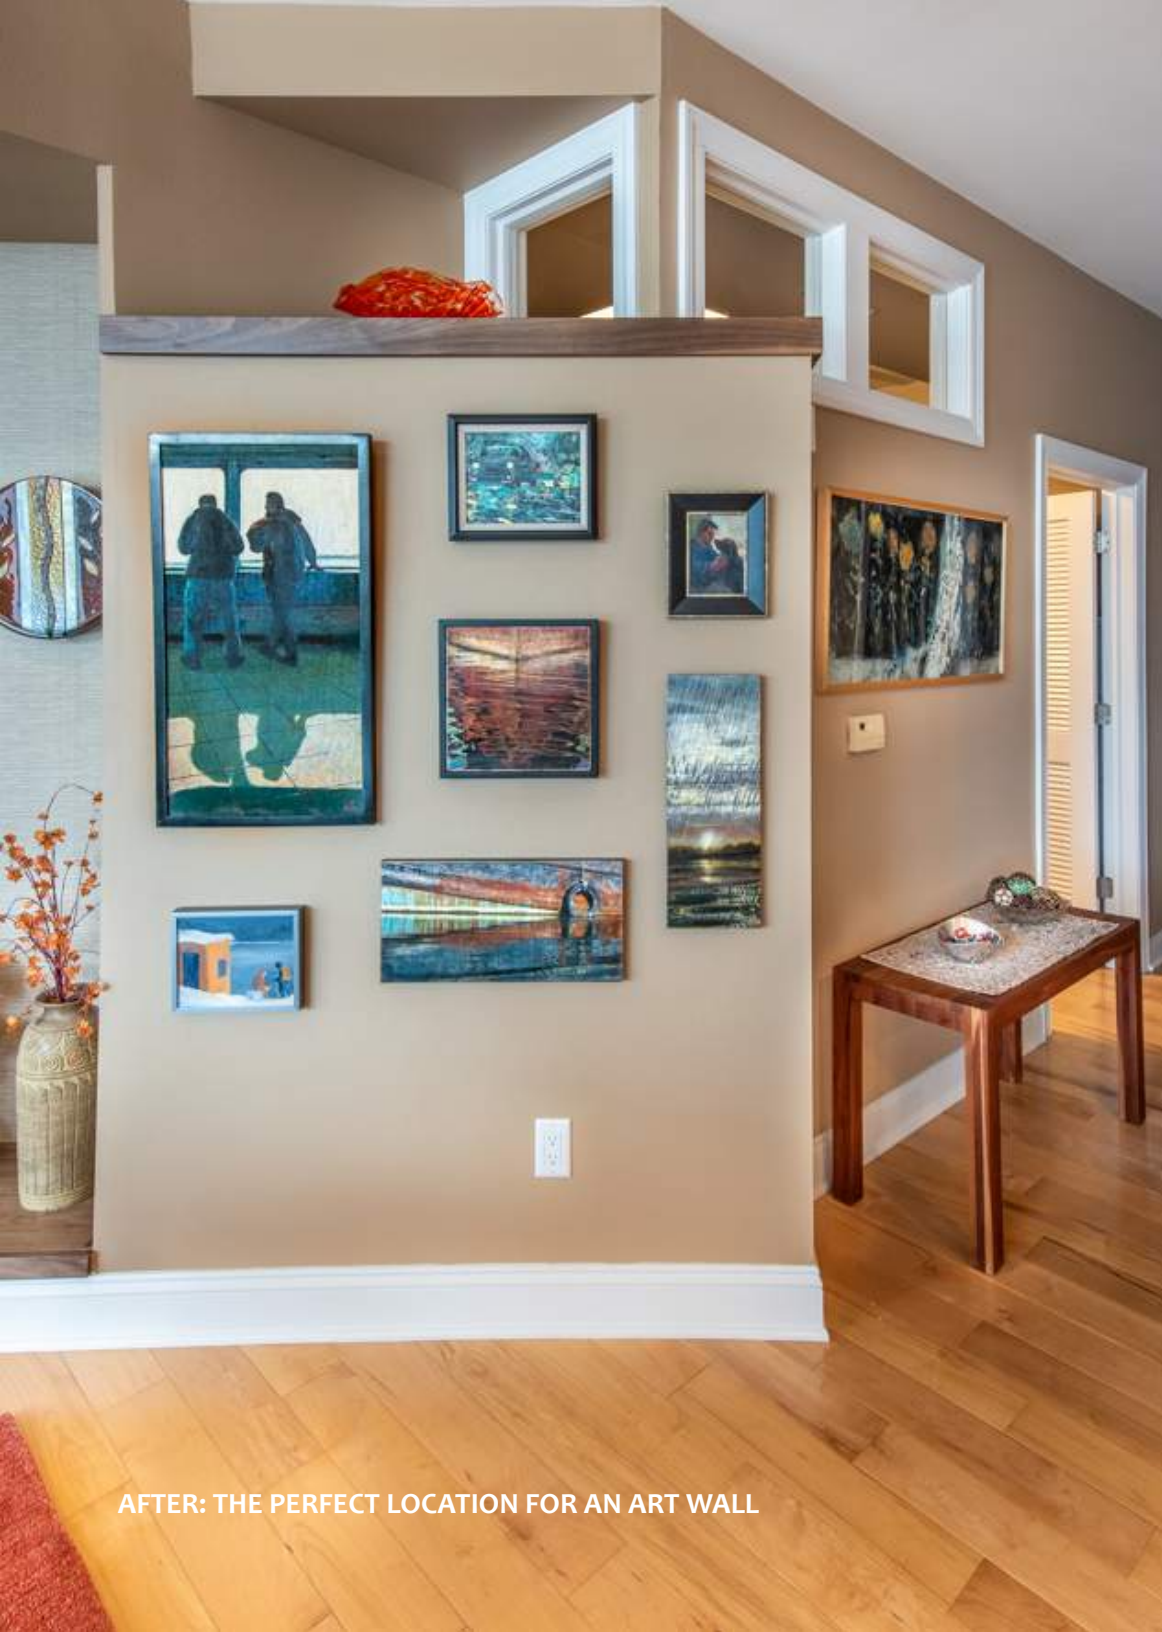
Across the way, where the fireplace used to be, now there is space for an art wall. But like the entertainment area, it is not just an ordinary art wall. It is a plane that extends just beyond the hallway in order to provide visual interest as you walk in the main entrance of the condo.

AFTER: THE PERFECT LOCATION FOR AN ART WALL

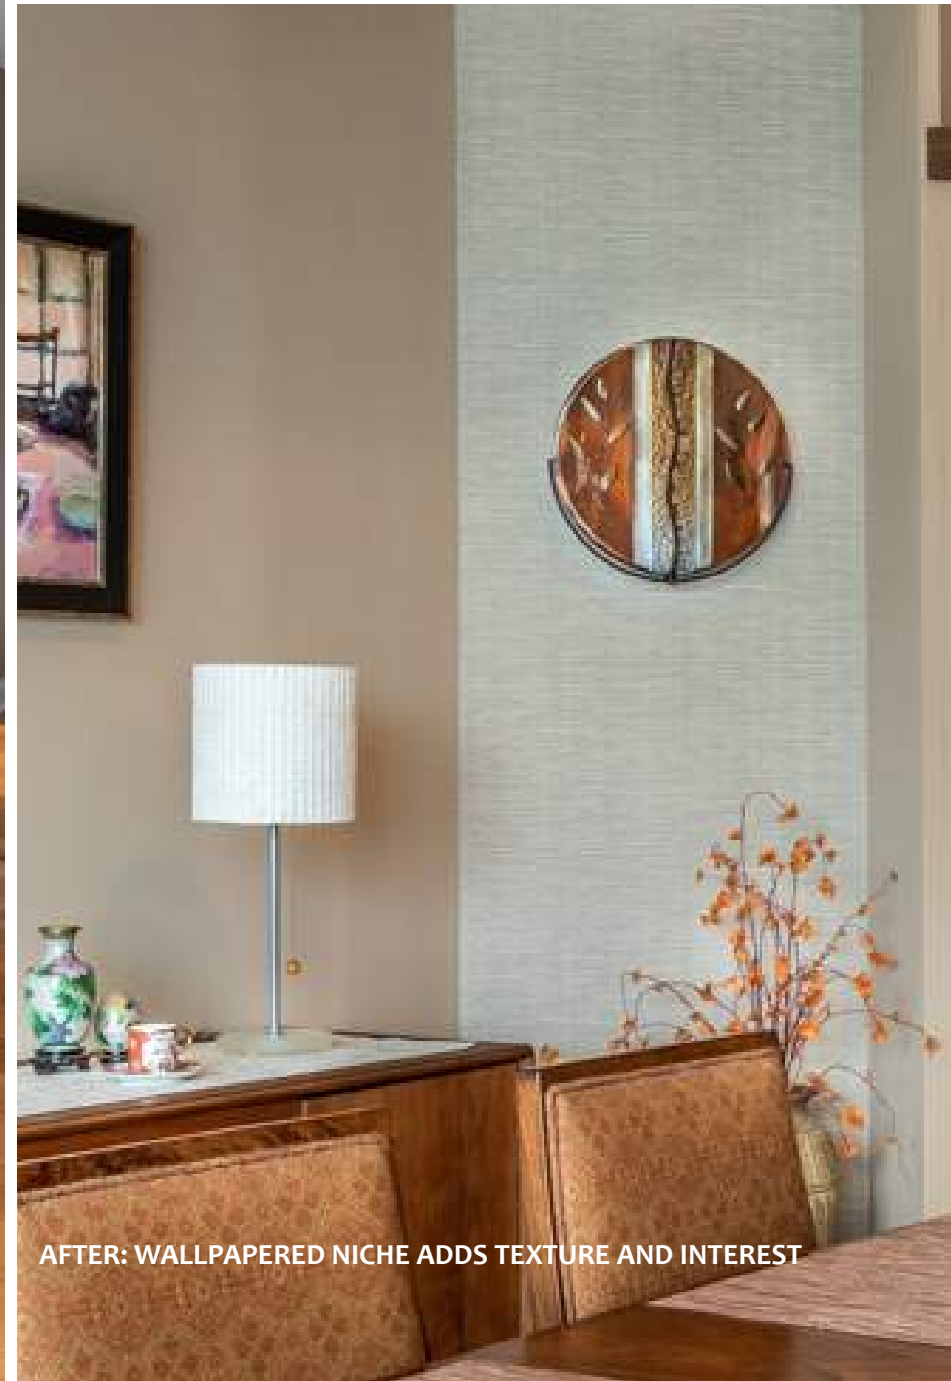
The same wallpaper is used on a niche within the area, and borrowed light windows were added above the art wall, bringing natural light in to the client's home office.

AFTER: WALLPAPERED NICHE ADDS TEXTURE AND INTEREST
